PRE-RENOVATION ASBESTOS CONTAINING MATERIALS SURVEY AND LEAD-BASED PAINT SCREENING REPORT

**Greenville Technical College
Engineering Technology Building 103
506 South Pleasantburg Drive
Greenville, South Carolina 29601**

Issue Date: September 13, 2020

F&R Project Number: 59Y-0393

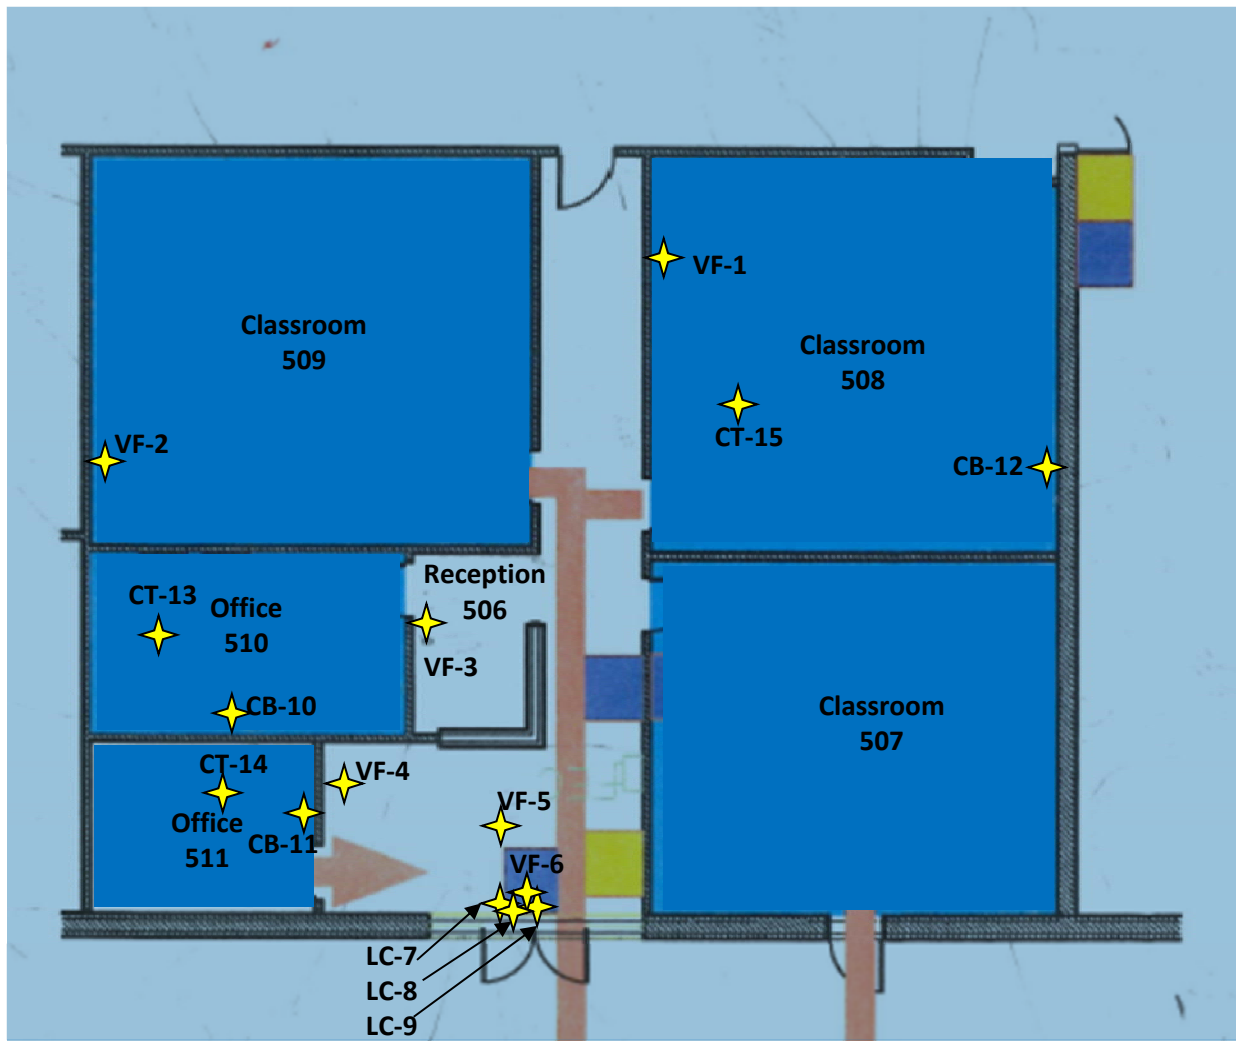
★ No Asbestos Detected

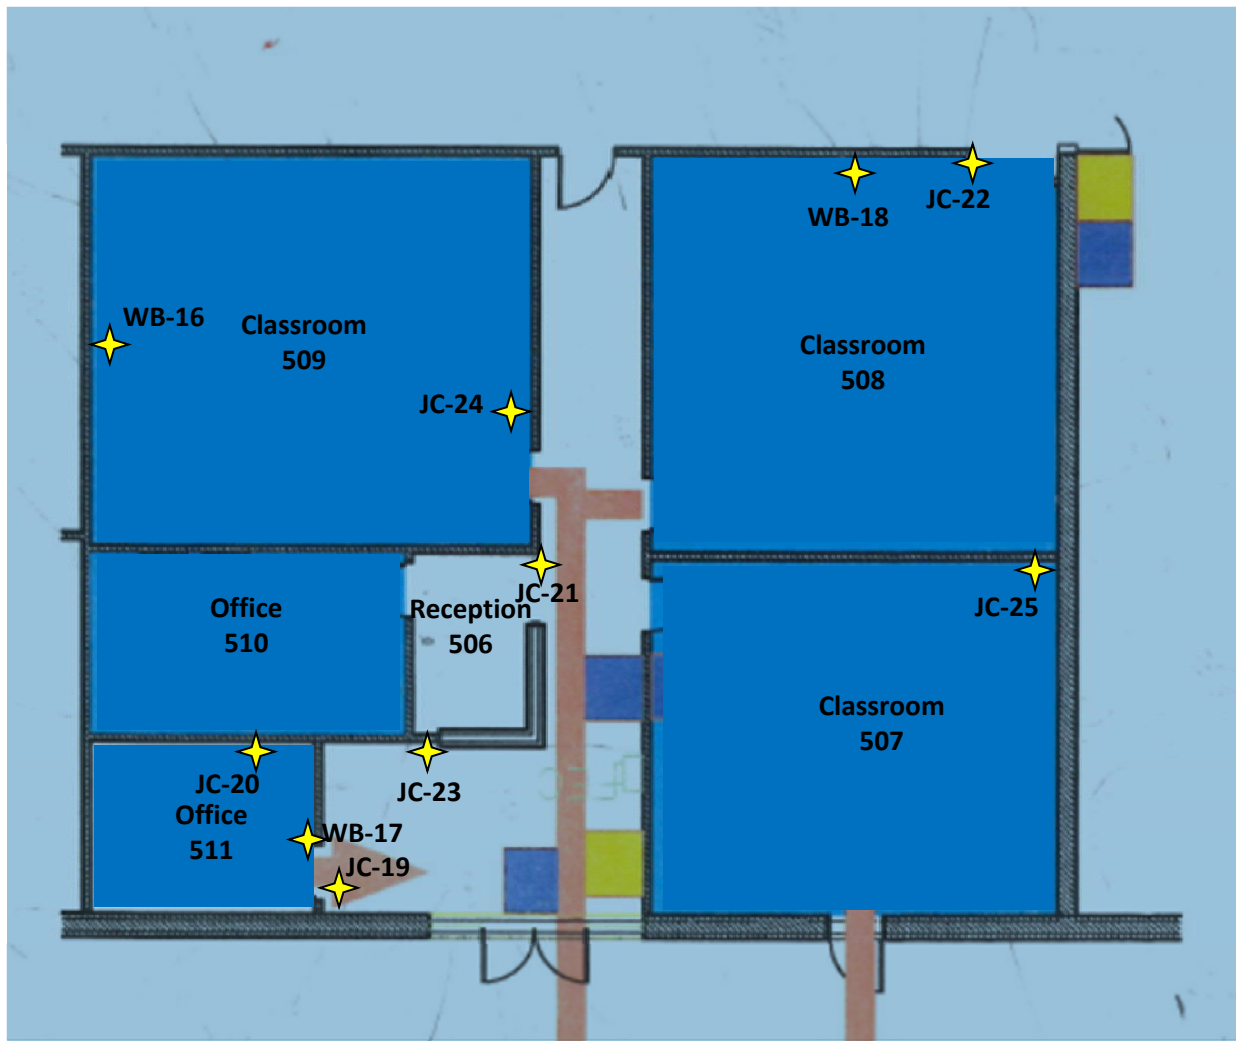
AREA 5: OFFICE AND CLASSROOM SAMPLE LOCATION PLAN 2

★ No Asbestos Detected

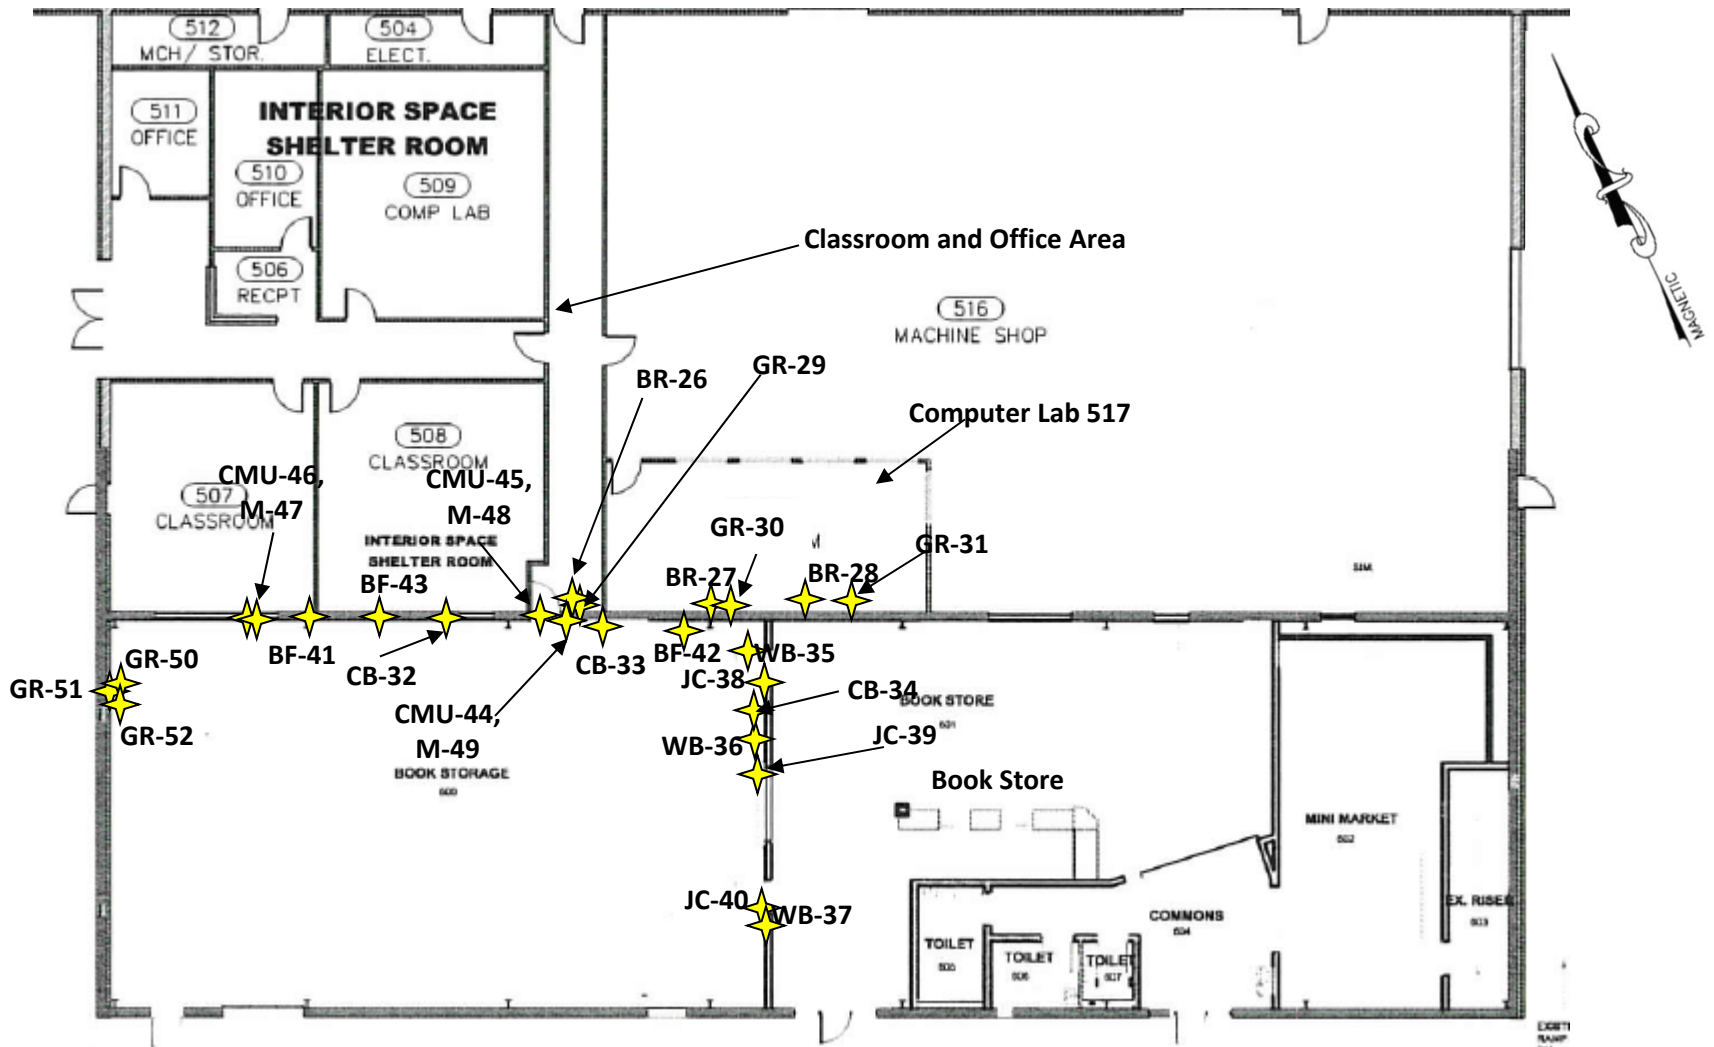
AREA 5: COMPUTER LAB AND BOOK STORAGE SAMPLE LOCATION PLAN 3

★ No Asbestos Detected

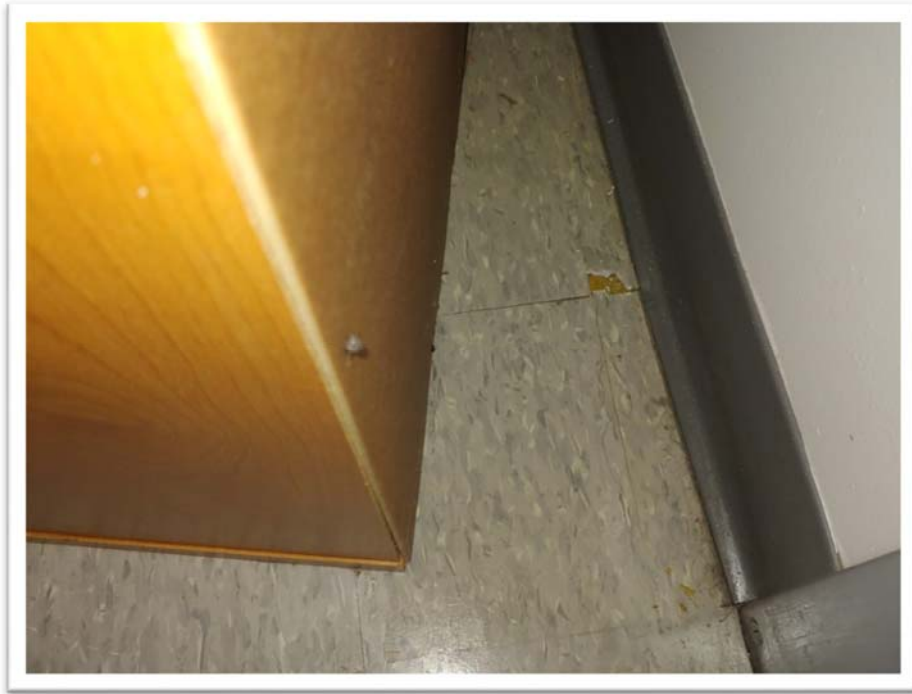
Photograph #011 View of light gray vinyl floor tile/mastic sampling point VF-3 (None Detected).

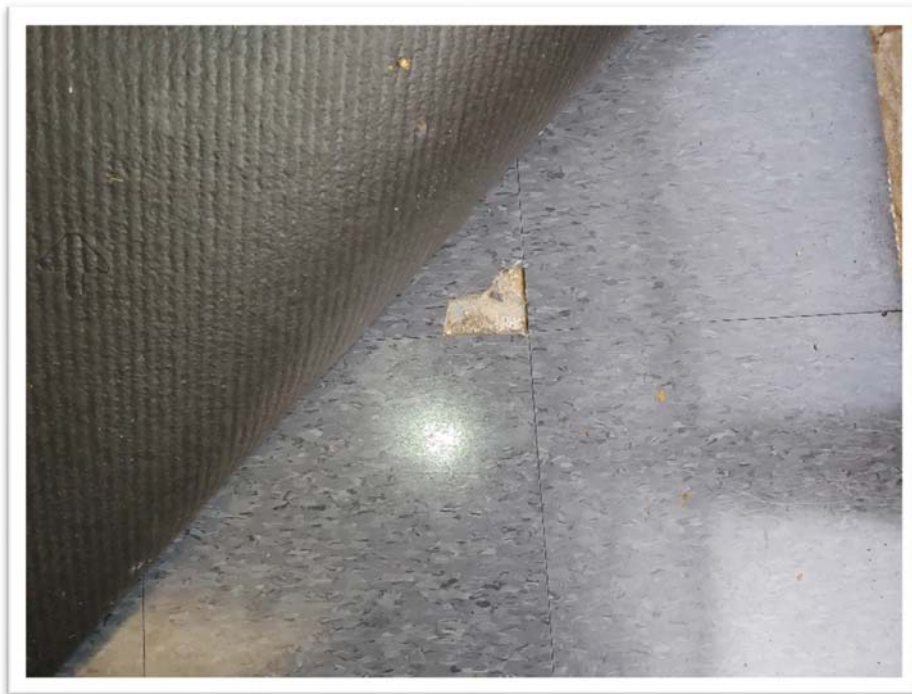
Photograph #012 View of dark gray vinyl floor tile/mastic sampling point VF-6 (None Detected).

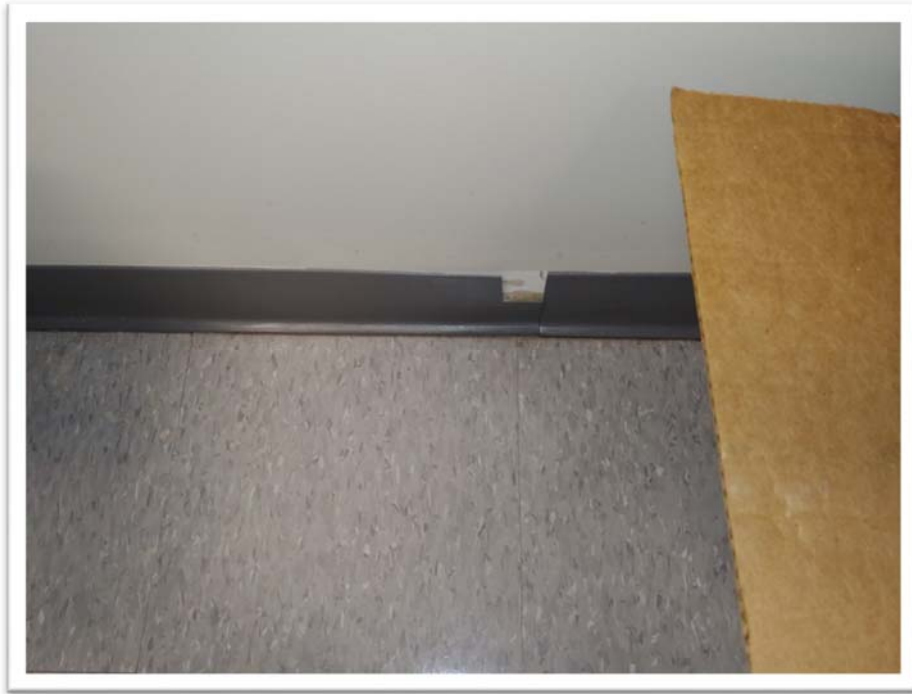
Photograph #013 View of the dark gray cove base sampling point (None Detected).

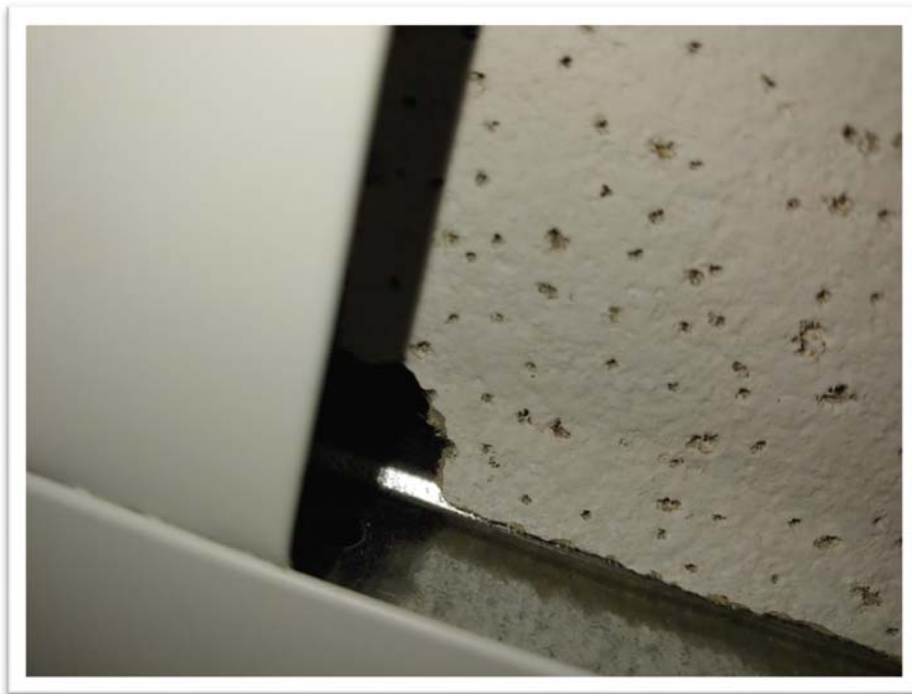
Photograph #014 View of ceiling tile sampling point (None Detected).

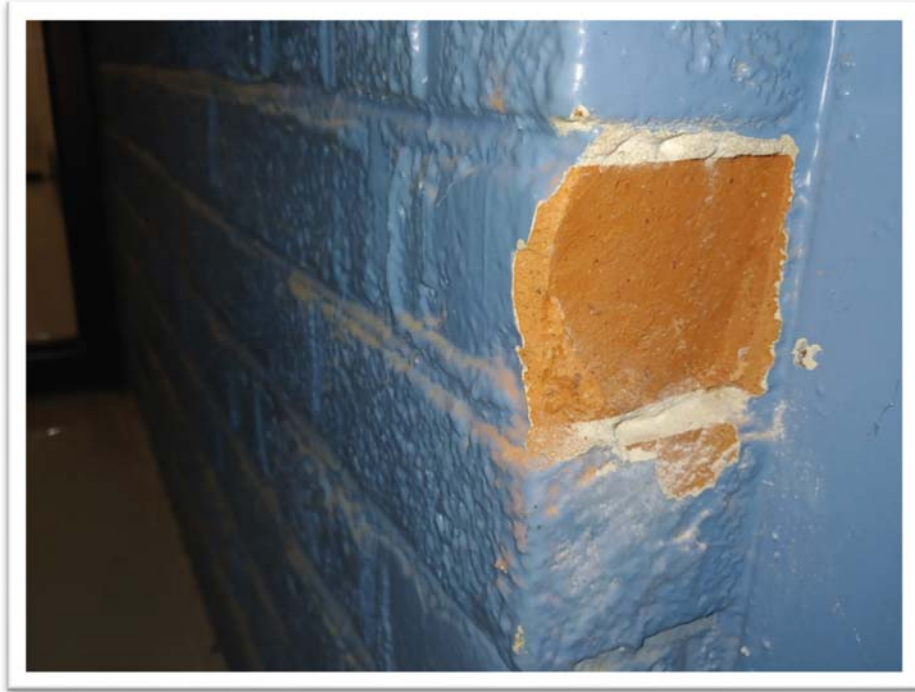
Photograph #015 View of brick and grout sampling point (None Detected).

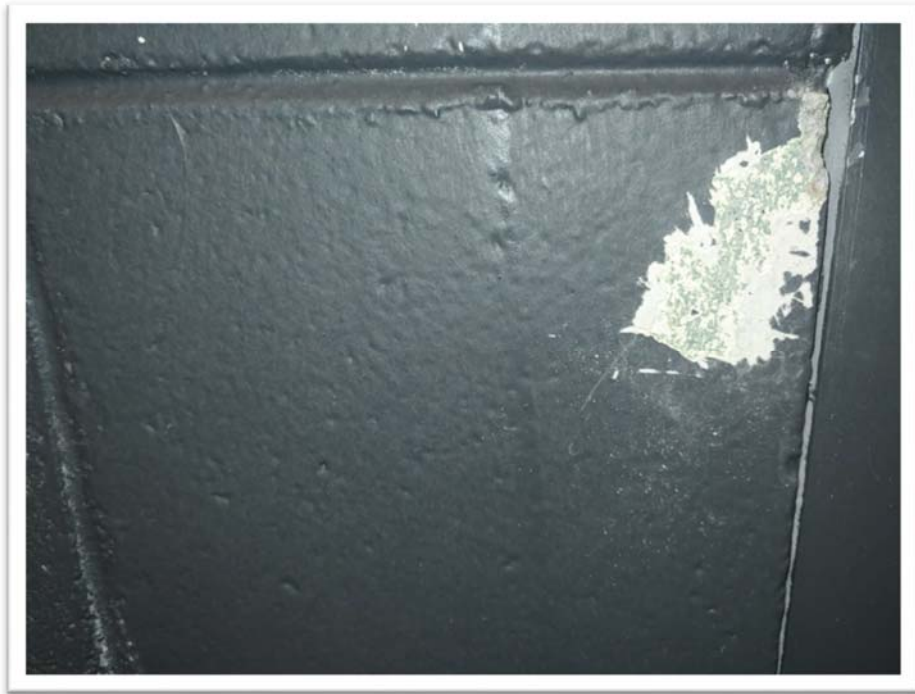
Photograph #016 View of CMU block filler surface coating sampling point (None Detected).

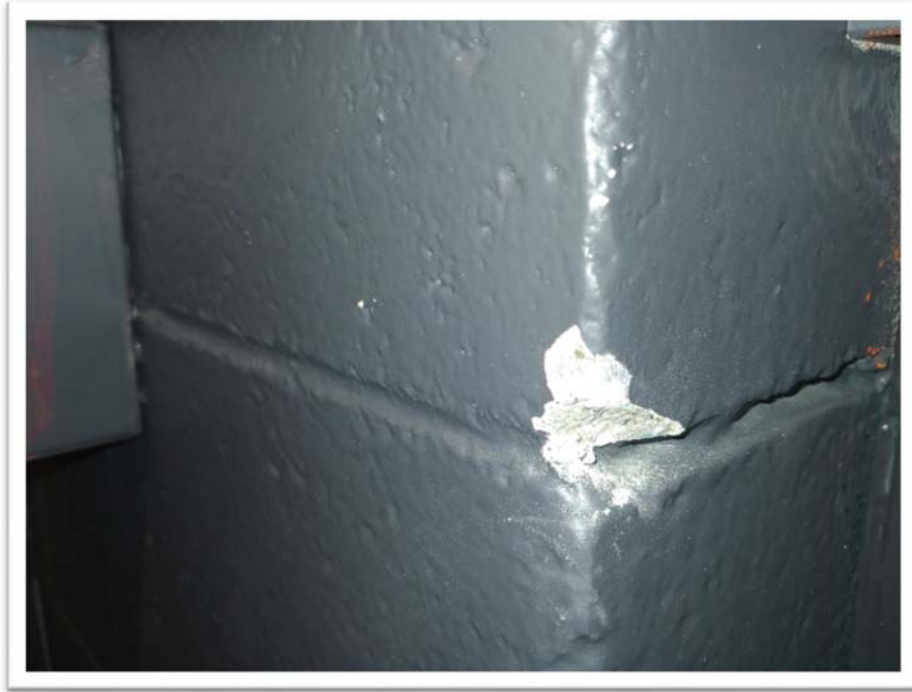
Photograph #017 View CMU block and mortar sampling point (None Detected).
